## FLIR B-Series infrared camera tells truth about walls and facades

*Building insulation quality becomes a pressing issue as heating costs soar. An infrared camera for building applications and the expert's eye can do a lot to save on energy.*

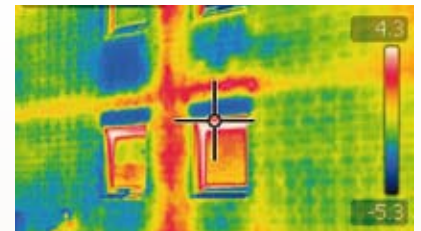
*Examples of inefficient piping insulation between kitchen and bathroom*

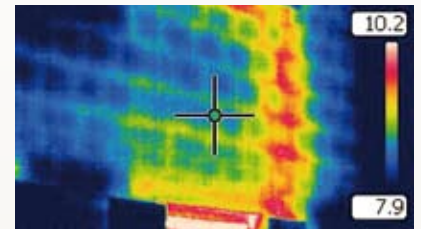
*Bad insulation above balcony window*
