APPLICATION STORY

The Västmanlands district main hospital, Västerås, Sweden

FLIR InfraCAM™ and E-Series infrared cameras save repair time and heating costs at hospital group

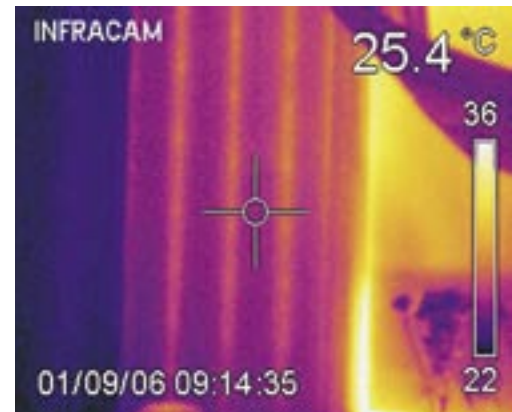
The image clearly shows where not to drill.

The infrared camera is also used by other contractors such as plumbers to look at water piping systems, especially prior to repair work, to be able to see where to drill (or not to drill), where (not) to break open floors or walls etc...Its use generates savings that are worth many times the price of a handheld infrared camera.
